CMAS Interactions with Advanced Environmental Barrier Coatings Deposited via Plasma Spray- Physical Vapor Deposition

B. J. Harder, V. L. Wiesner, and D. Zhu

NASA Glenn Research Center, Cleveland OH 44135

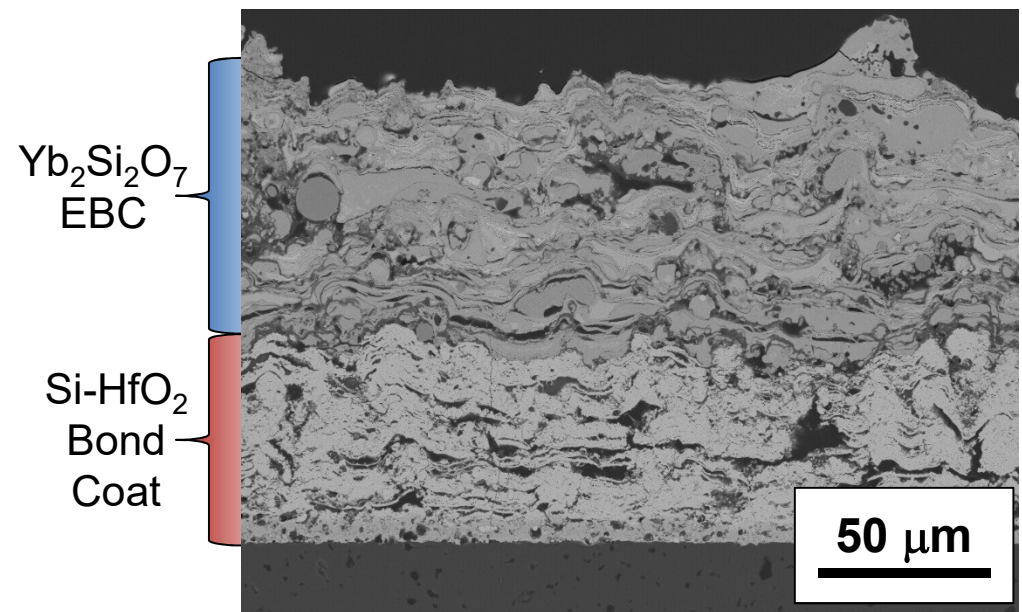
As-deposited 2-layer EBC

- Bulk SiC substrates 0.5" x 0.75"
- Bond coat was Si-HfO₂
 - “Bricks and Mortar” structure
 - Starting powder 30/70 mol% HfO₂/Si
- SiO₂-lean Yb-silicate
 - 35 mol% Yb₂O₃ bal SiO₂
 - Fully reacted 85/15 wt% Yb₂Si₂O₇/Yb₂SiO₅
 - After deposition coating contained some free SiO₂ (~10 wt%)
- Heated in air to 1300°C for 20hr prior to CMAS exposure

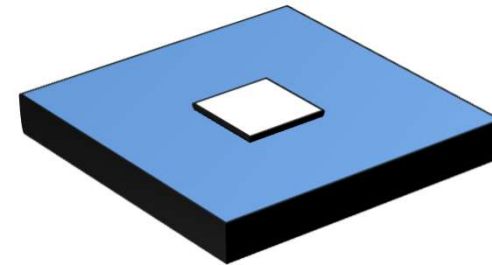
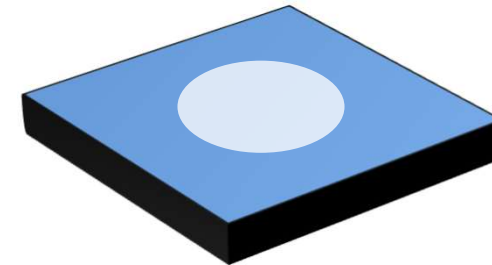
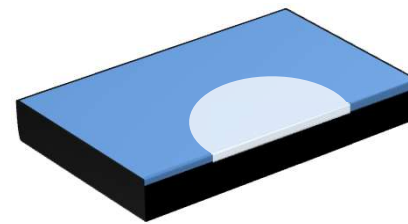
1200°C/10hr

- Tape became shiny and exhibited wetting on the surface of the coating
- Total 'affected zone' was ~5mm
- Macro image showed the glass did not go fully molten
